# Manhole Inspection Summary

Manhole # S47E\_\_045MH

Insp Date: **7/24/08 12:18 PM**

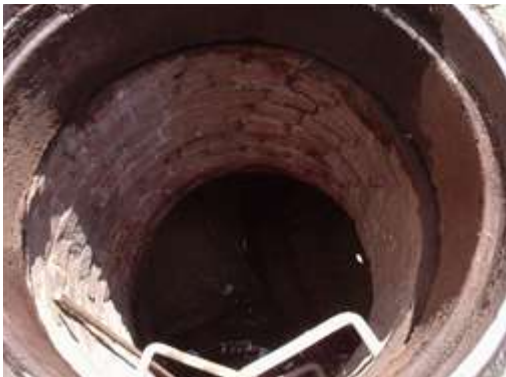
Defect 2

frame leaks

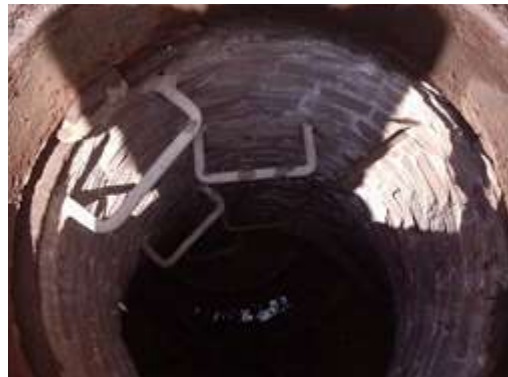
Defect 1

Condition: ☐ Sound ☐ Cracked ☐ Root Intrusion ☒ **Loose Brick** ☐ Deteriorated

Infiltration: ☐ None ☐ Joint ☐ Cracks ☒ **Mortar** ☐ Roots ☐ Wall

Loose Bricks

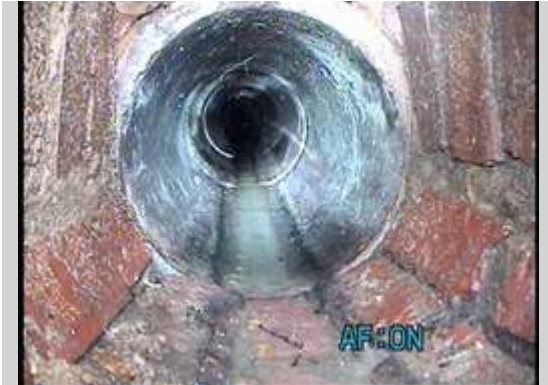
12 O'Clock Outflow

Pipe Height: **8.4** (in.) Rod and Bar (Angled)  
Pipe Material: **Clay** ☐ Pipe Lined  
Invert Depth: **8.50** (ft.) Flow Characteristics: **Fast**  
Deposits: ☒ None ☐ Mud ☐ Sludge ☐ Debris ☐ Grease  
Silt Depth: (in.) Deposits Extent:  
Infiltration: **None** Pipe Seal Cond: **Sound**

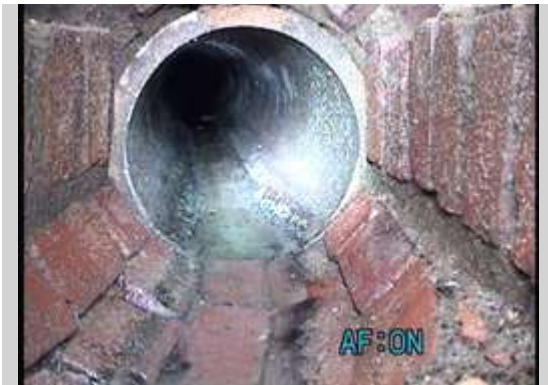
3 O'Clock Inflow

Pipe Height: **8.4** (in.) Rod and Bar (Angled)  
Pipe Material: **Clay** ☐ Pipe Lined  
Invert Depth: **8.45** (ft.) Flow Characteristics: **Fast**  
Deposits: ☒ None ☐ Mud ☐ Sludge ☐ Debris ☐ Grease  
Silt Depth: (in.) Deposits Extent:  
Infiltration: **None** Pipe Seal Cond: **Sound**

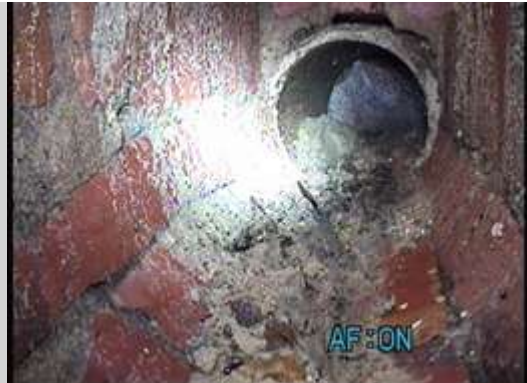
6 O'Clock Inflow

Invert Depth: **8.30** (ft.) Flow Characteristics: **None**

Infiltration: **None**

Pipe Seal Cond: **Sound**
